Inspection Report

Inspection Connection

Michael A Clark, Certified Home Inspector

123 Any Street
Somewhere, WV 12345

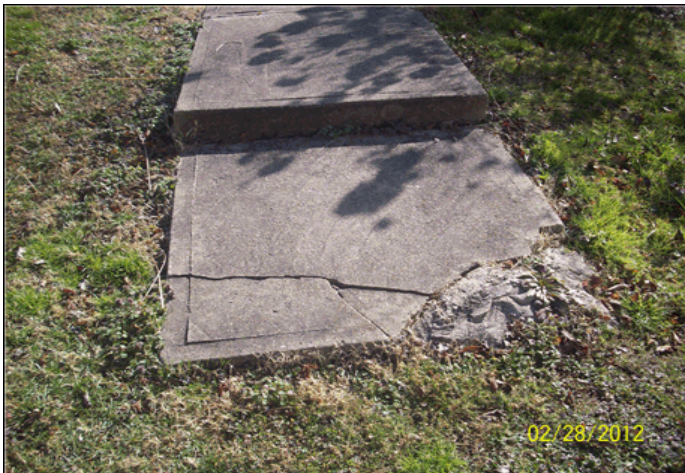
2) Driveway - Sidewalk Conditions

Common cracks were observed in the driveway and sidewalk. Recommend maintenance as needed.

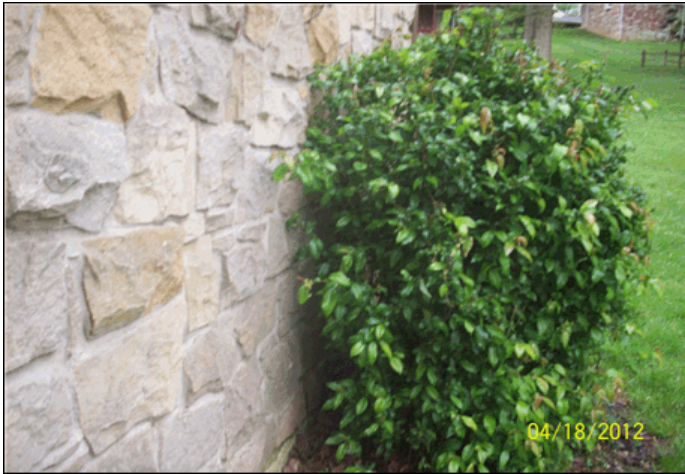
3) Vegetation Conditions

shrubby within 1 foot of house should be cut back and maintained 1 foot clearance to prevent insect and moisture problems.

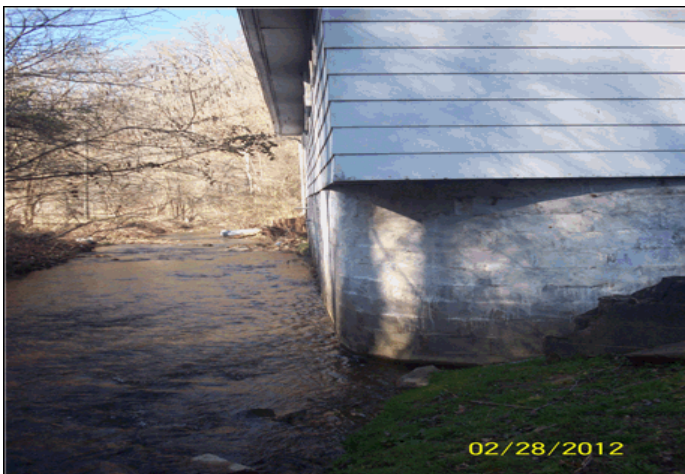
5) Back Entrance Conditions

The back of the house's footing and foundation is in a creek. There is no backyard.

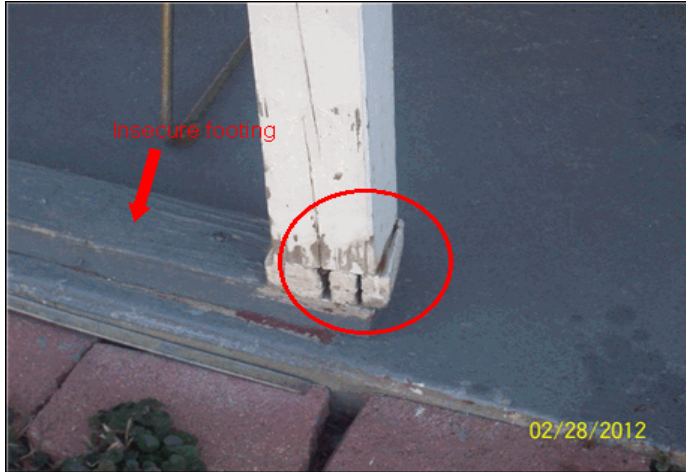
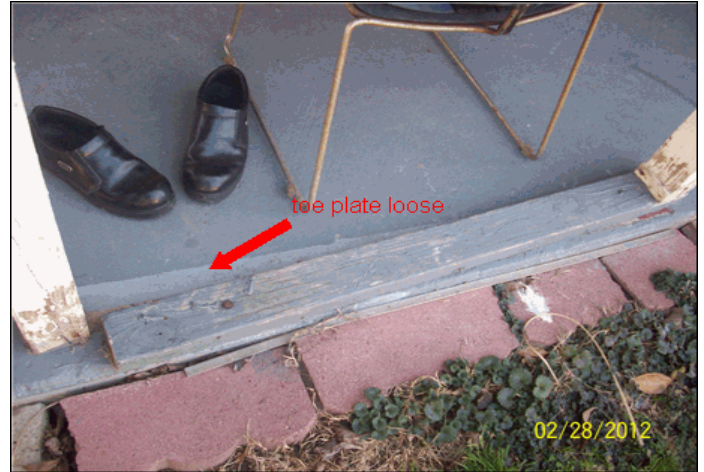
6) Carport

One of the posts on the carport is in pieces, and some of the footing (toe plate) is not secure. Recommend repair by a qualified contractor. An extension cord was used as permanent wiring for the ceiling fan. Any time an extension

cord is used as part of a circuit it is considered a safety hazard. Recommend further evaluation and / or repair by a licensed electrician prior to close.

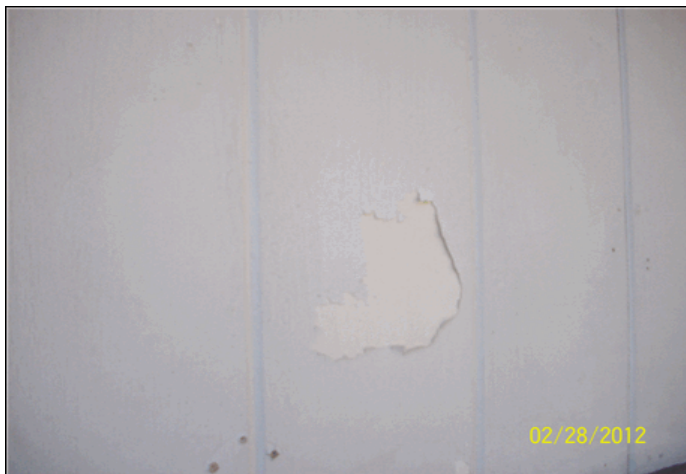
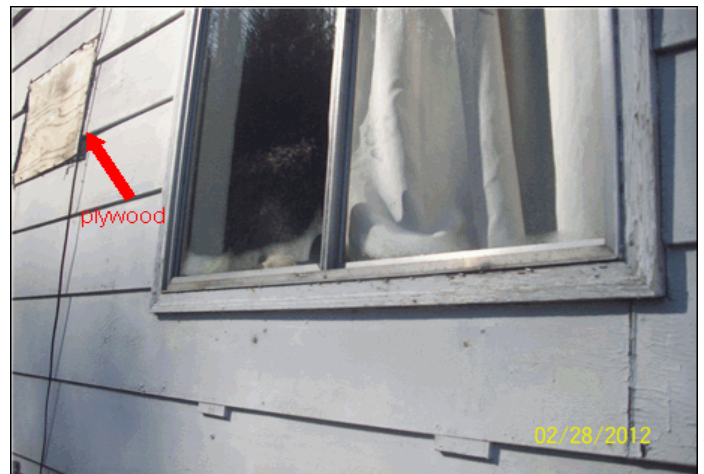
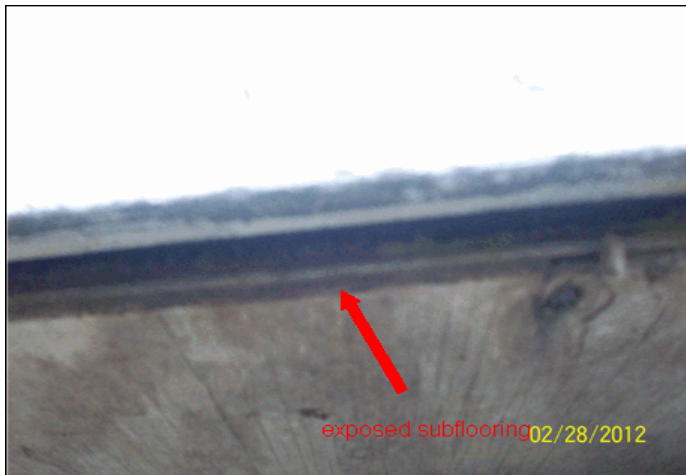
7) Exterior Wall & Trim Conditions

The paint / finish of the siding and trim was weathered. Recommend maintenance as needed by a qualified contractor. A section of the wall covering has been cut and a piece of plywood is nailed to the North side exterior wall. Some trim is missing and some of the sub floor is exposed and loose on the Northeast corner.

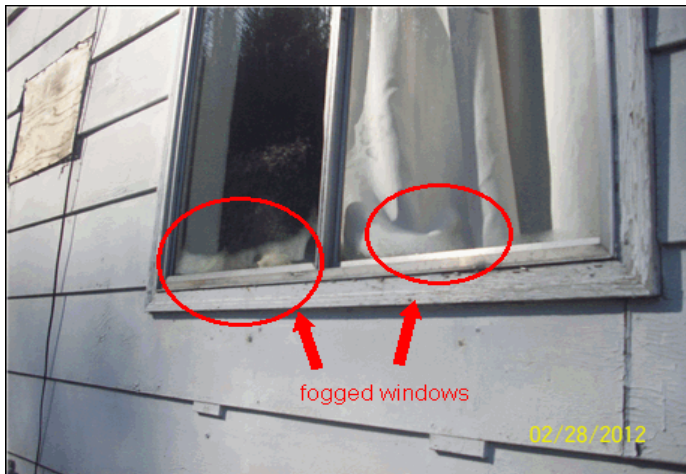
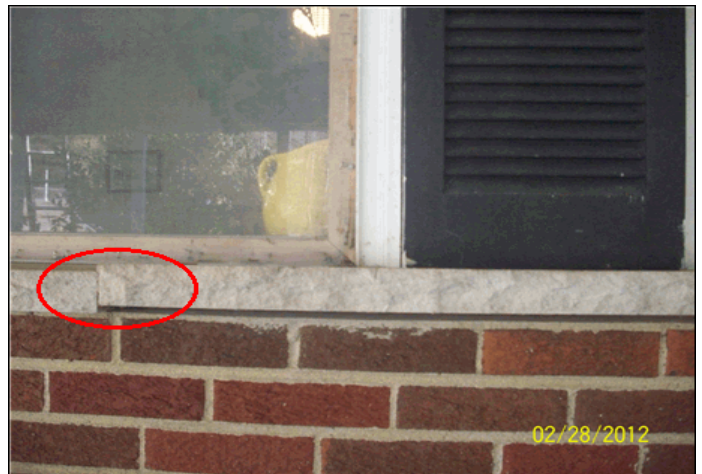
8) Window Conditions

The thermal pane window at the North side appear to have lost its thermal seal. Moisture, fogging, and hazing are common signs of this condition. While mostly cosmetic, this condition is generally not repairable. Correction would require replacement of the window(s). Some of the window screens were missing or not installed. The window sill from the kitchen to the carport is broken and unlevel.

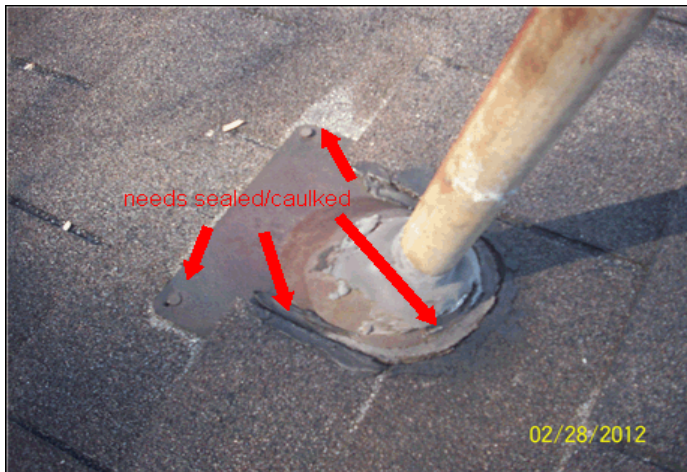
13) Condition of Roof Penetrations

Separations were observed at the vent boot and pipe on the Southwest. Sealing is needed. Recommend further evaluation and repair as needed by a qualified / licensed contractor.

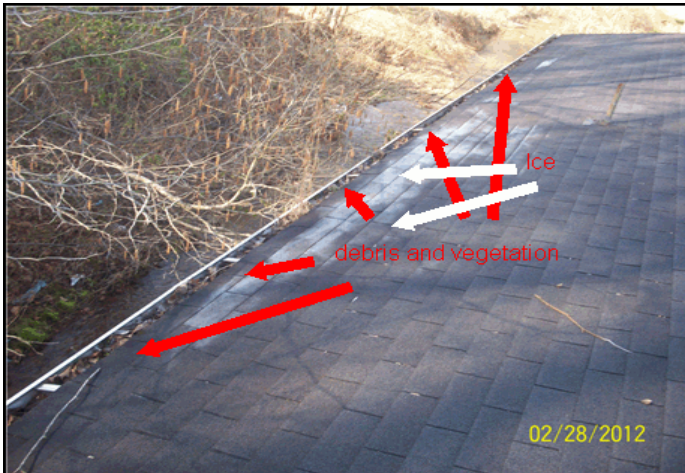
14) Gutter & Downspout Conditions

The gutters were filled with leaves and debris at the time of the inspection. Suggest cleaning and removal of debris on a regular basis. This condition can cause water penetration at the eave area.

Some of the warped sheathing on the roof could be caused by improper ventilation. There is a ridge vent and gable vents, but the soffits are unvented, and there was a small amount of frost built up in a few areas at the inspection. (see gutter picture also)

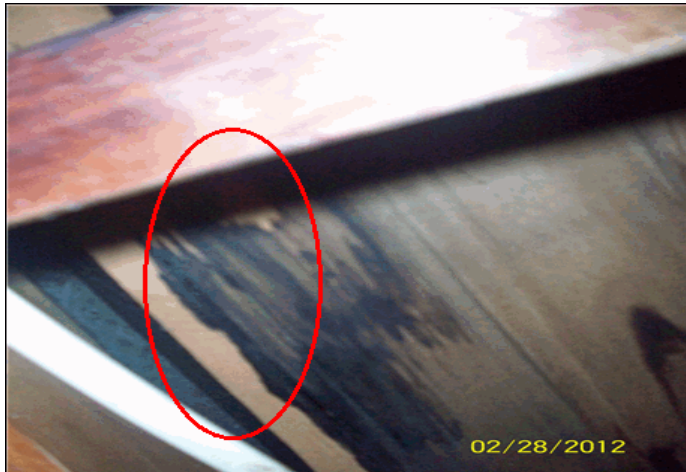
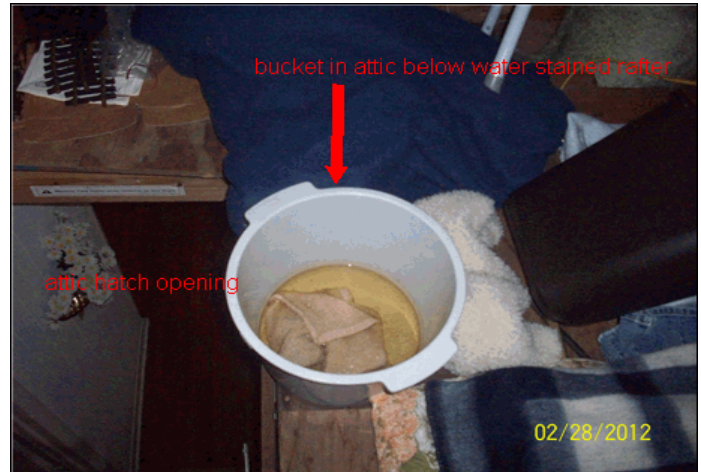
16) Ceiling Frame Conditions

Minor water stains were observed. The inspector was unable to determine if the water stains were active at the time of the inspection. The stains may have been caused by condensation or leakage at a previous time. The inspector does not offer an opinion or warranty as to whether the roof leaks now (unless it is moderately raining at the time of inspection) or is subject to future leakage. Client should obtain disclosure / history information from the current owner or occupant prior to close. A small bucket containing a small amount of water was observed in the entrance, and the rafter over the bucket is water stained. It is not know whether this is to catch leaking water or not.

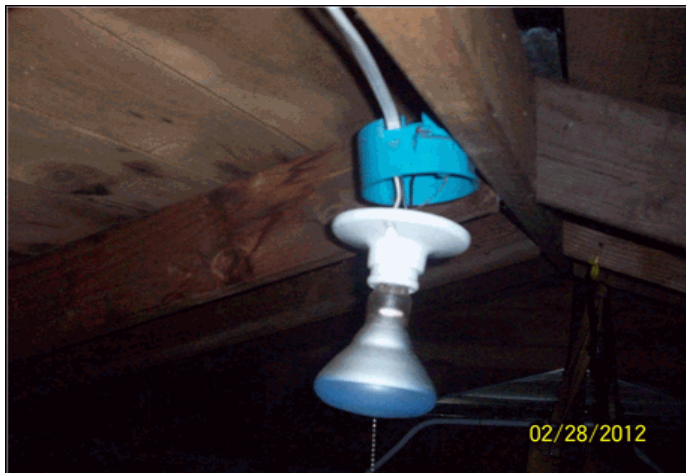
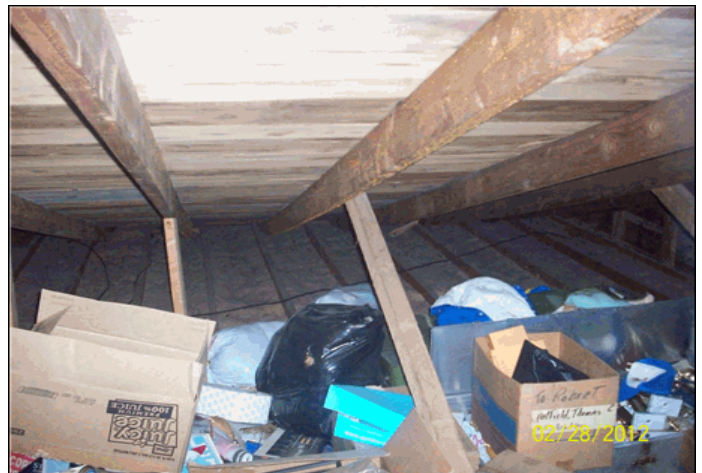
18) Attic Area Condition

The lighting fixtures in the attic were not secured to the J-box, and there was no switch in a conspicuous area to turn the lighting on. There was an excessive amount of storage items in the attic that obstructed a full inspection.

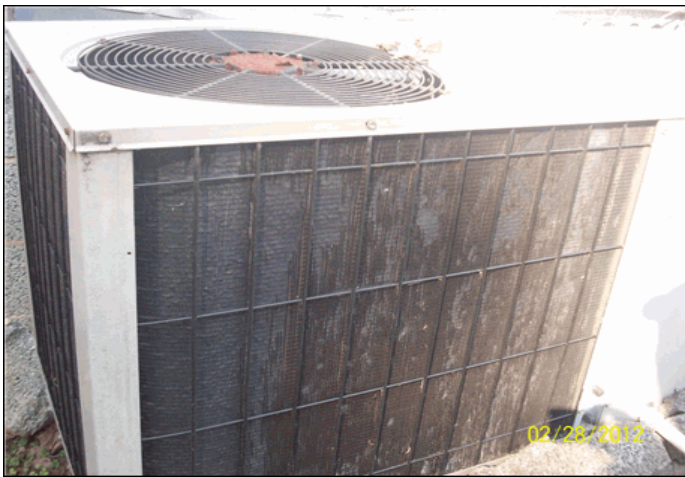
19) Unit Conditions

The system is older and appears to be past its normal life expectancy. Client should consider replacement with a modern unit conforming to modern safety standards and efficiencies. The system is older and appears to be past its normal life expectancy. Client should consider replacement with a modern unit conforming to modern safety standards and efficiencies. The heating system was operational at time of inspection. This is not an indication of future operation or condition. Some of the cooling fins were bent and may cause obstruction of air flow to the compressor.

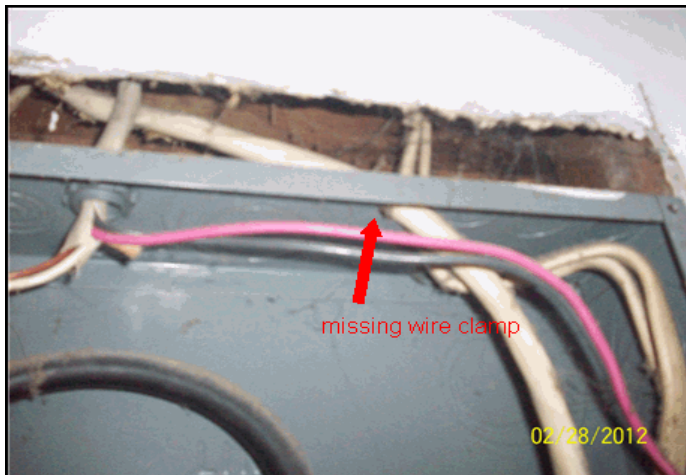
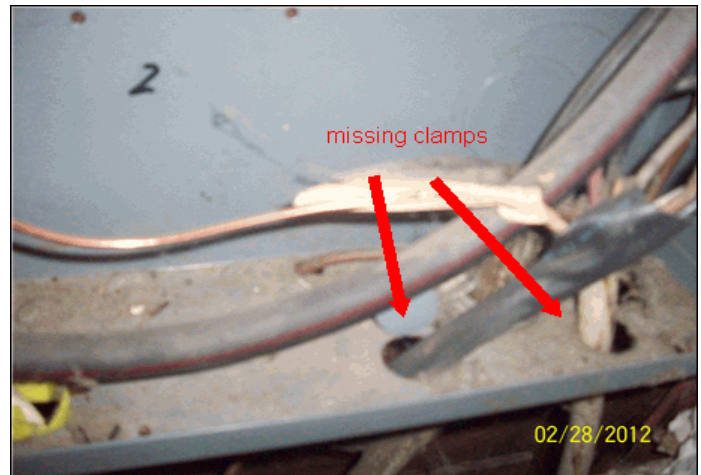
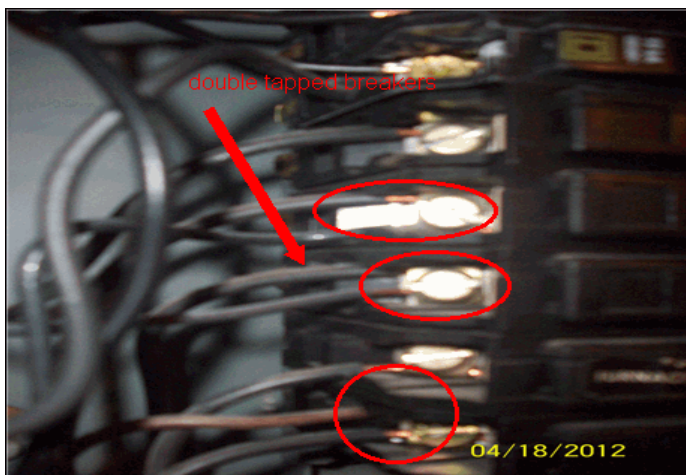
26) Electrical Panel Conditions

Two or more wires were connected to one breaker in the panel. This condition can add to the load of the affected electrical circuit(s) causing a possible overload, tripping, or arcing at the breaker(s). Current standards require circuits to be independently protected. Recommend an electrician properly separate circuits. There were a number of clamps missing to secure the cables exiting the main panel.

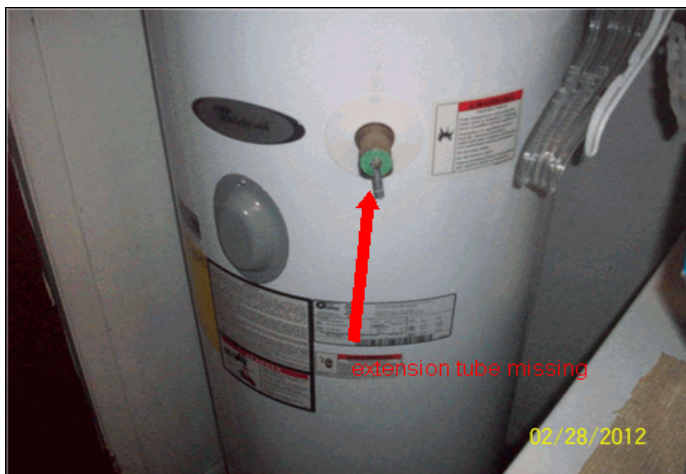
32) Water Heater Conditions

T P R (temperature pressure relief) valve overflow pipe was missing at the time of the inspection. Recommend installation of an extension pipe for increased safety. Client should consult a licensed plumber for additional information.

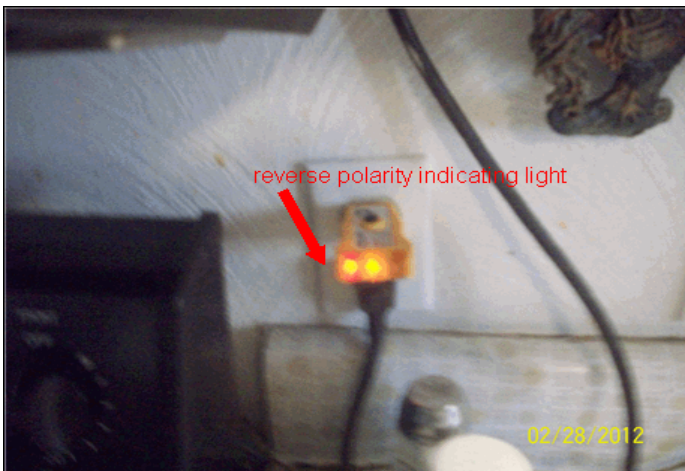
51) Electrical Conditions

Reverse polarity was noted at outlet located beside the microwave . Reverse polarity, (hot and ground / neutral reversed) are usually corrected by minor wiring adjustments at the specified item. However, when a number of these conditions are observed, client should consult a licensed electrician.

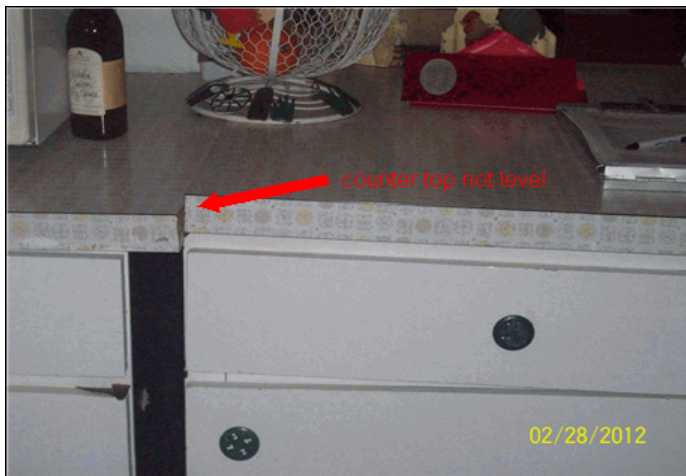
54) Counter Conditions

The counter is loose/raised below the pass-thru to the living area

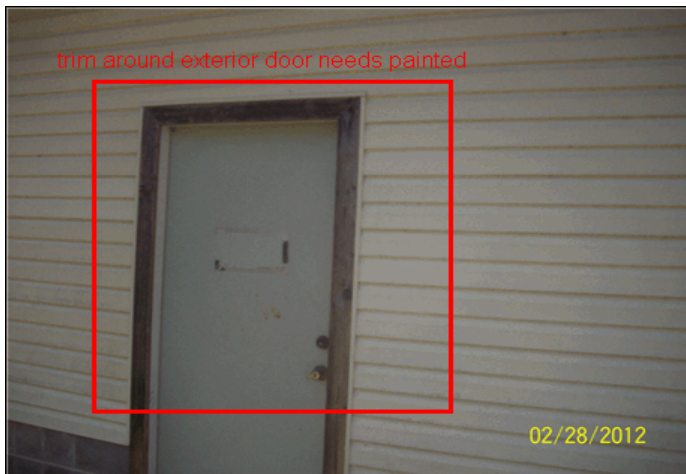
83) Door Conditions

R The exterior entrance door to the garage has unpainted trim. This can cause premature rotting, insect penetration, and/ or mold and fungus growth.

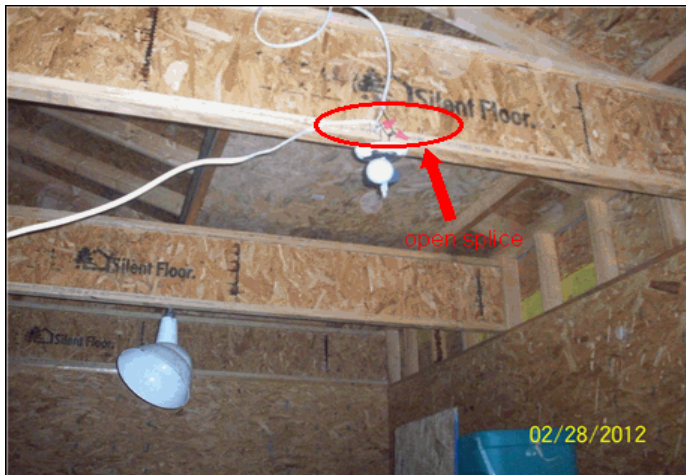
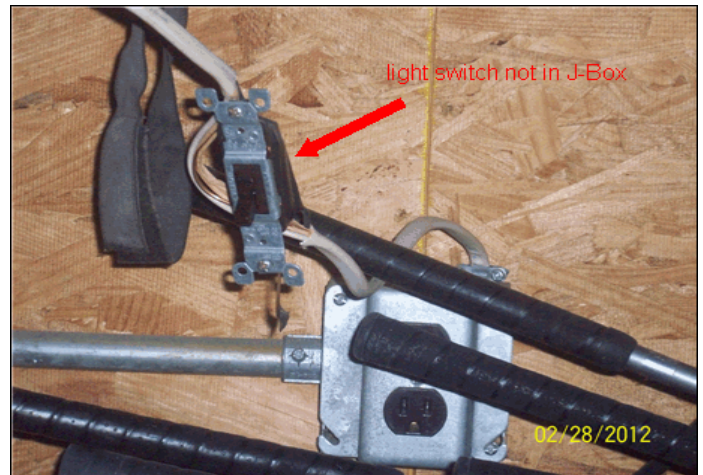
85) Electrical & Lighting Conditions

S Unprofessional wiring was observed inside the garage. Recommend further evaluation and repair as needed by a licensed electrician. Exterior Romex / UF type wire was observed servicing the detached garage. Exterior wire(s) not enclosed in conduit may be subject to physical damage or contact with water. Although the installation of this type of wiring may have been proper at the time of installation, exterior or exposed wiring should be enclosed in a weather protective conduit. Client is advised to consult with a licensed electrician.

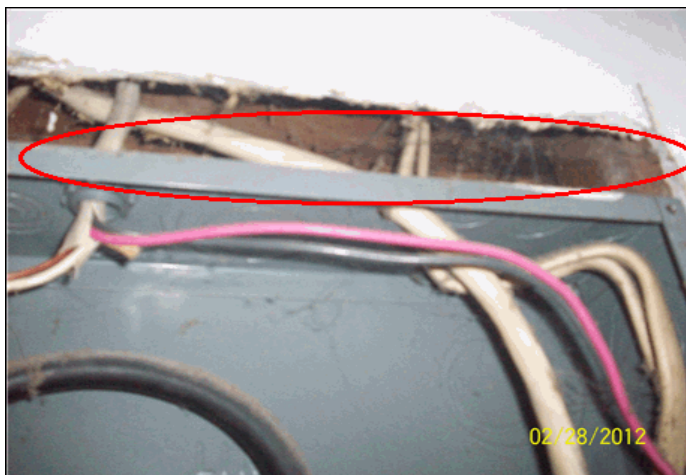
86) Laundry Room Conditions

There is a hole cut in the drywall around the main breaker panel that is bigger than the panel, leaving gaps for outside air to penetrate and inside air to escape the room

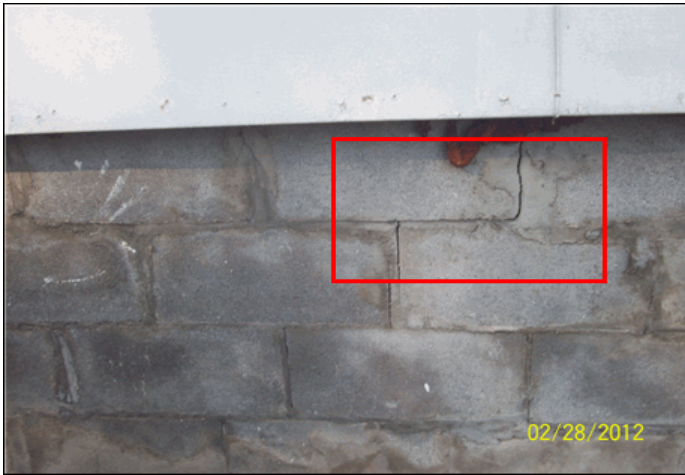
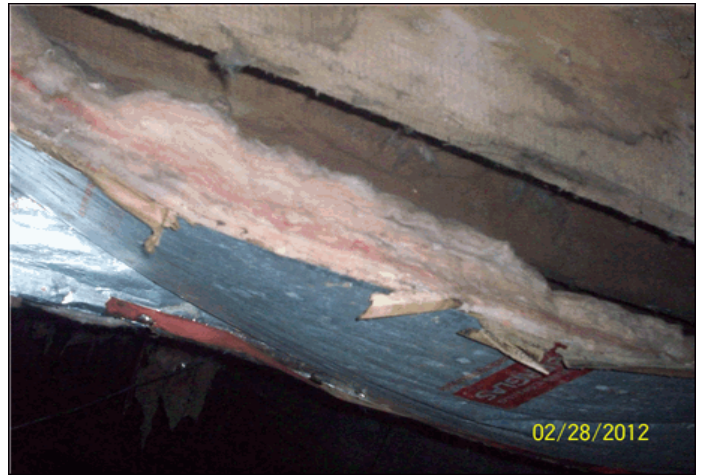
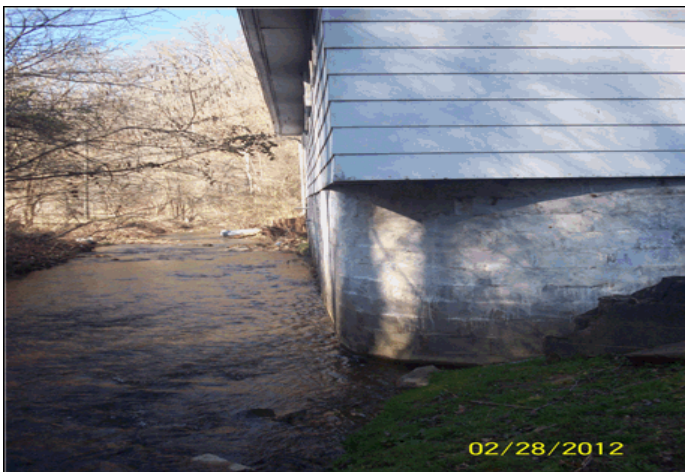
89) Foundation Conditions

A crack of approximately 1/8" or less was observed in the foundation wall. The cracking implies that some foundation movement has occurred. Recommend masonry sealing and monitoring for any further movement. Although no obvious evidence suggesting "immediate" concern was observed, this does not however guarantee future conditions. The exact / precise measurement of such conditions is not within the scope of our inspection. Past or future movement may be related to soils and geological issues, which are beyond the scope of our expertise. Most of the floor insulation has fallen down, and the vapor barrier on the insulation that is installed is upside down. Only partial vapor barrier between earth and crawlspace area. It was also noted in the EXTERIOR section of this report the foundation on the south side is sitting in a creek bed. There does not appear to be any damage or water penetration from the creek into the foundation, but is still a concern worth monitoring.

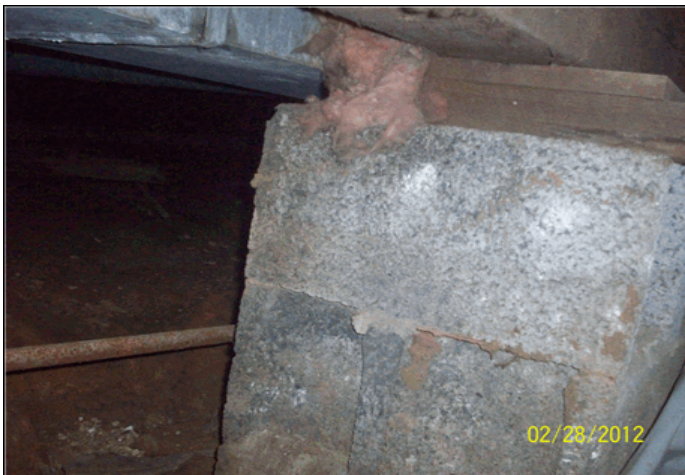
90) Flooring Support Conditions

The column / support is block columns.
