Inspection Connection

Property Inspection Report

123 Main Street, Anyplace, WV
Inspection prepared for: Mickey Mouse
Date of Inspection: 12/3/2014 Time: 10:00am
Age of Home: 2009 Size: 5200
Weather: recent rain

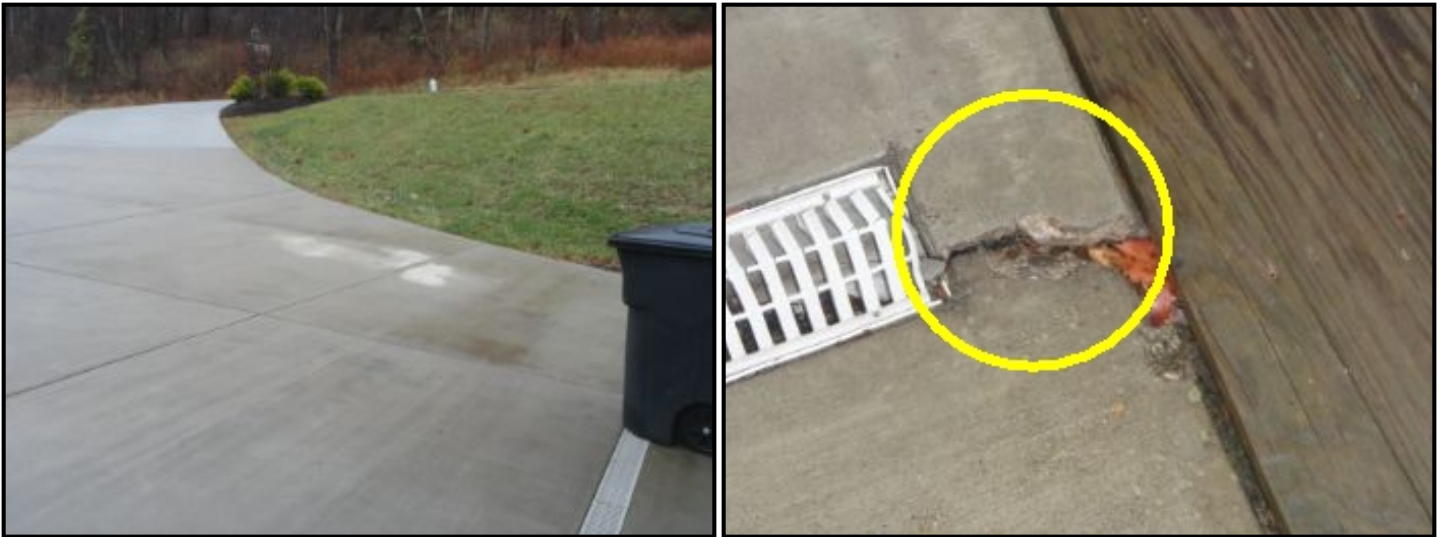
- Driveway in good shape. Recommend sealing to extend life.
- Minor settlement, or "hairline" cracks in driveways, are normal for properties of any age. They should, however, be monitored for expansion and sealed as necessary.
- **Broken concrete at the driveway in front of walkway. This is a potential tripping hazard. Recommend repair and or replacement of the displaced walks.**

Grounds		
Page 3 Item: 1	Driveway and Walkway Condition	<ul style="list-style-type: none"> Broken concrete at the driveway in front of walkway. This is a potential tripping hazard. Recommend repair and or replacement of the displaced walks.
Page 5 Item: 10	Patio and Porch Deck	<ul style="list-style-type: none"> The deck board at the bottom walkway needs secured Wood to Soil Contact at deck supports. Deterioration may occur and insects may gain access to wood.
Roof		
Page 8 Item: 3	Gutter	<ul style="list-style-type: none"> Downspout on Southeast drains directly on the roof shingles. This can cause premature wear and damage to the shingles. Recommend extending downspout to gutter below.
Attic		
Page 11 Item: 2	Structure	<ul style="list-style-type: none"> A vertical roof brace on East side of attic is not attached at the top.
Bathroom		
Page 20 Item: 7	Exhaust Fan	<ul style="list-style-type: none"> The fan for bath at top of stairs (upper level) terminates improperly in the attic. This can create excessive moisture. Recommend directing the vent towards the exterior to allow for proper ventilation. http://www.charleston-home-inspector.com/content/bath-vents-attic

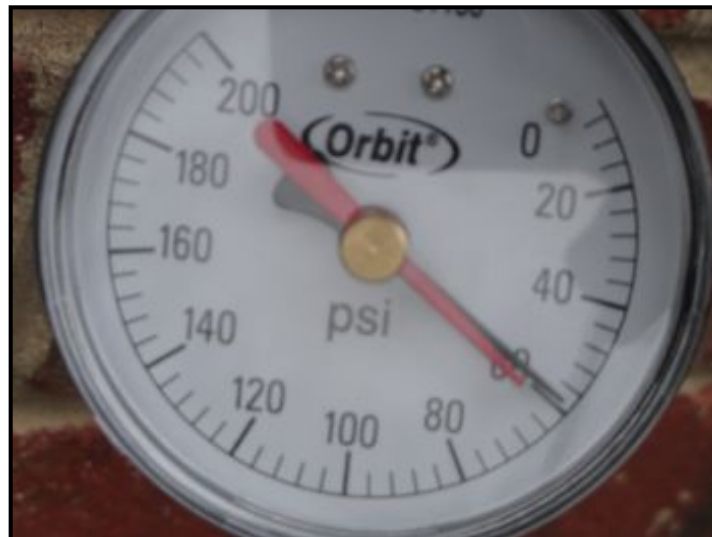
60 pounds Water Pressure

- 60

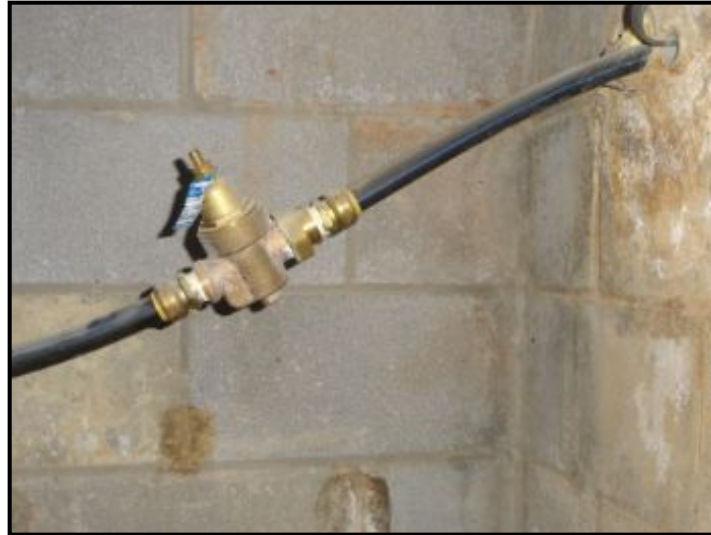
Water Pressure Regulator

- Pressure regulator noted.

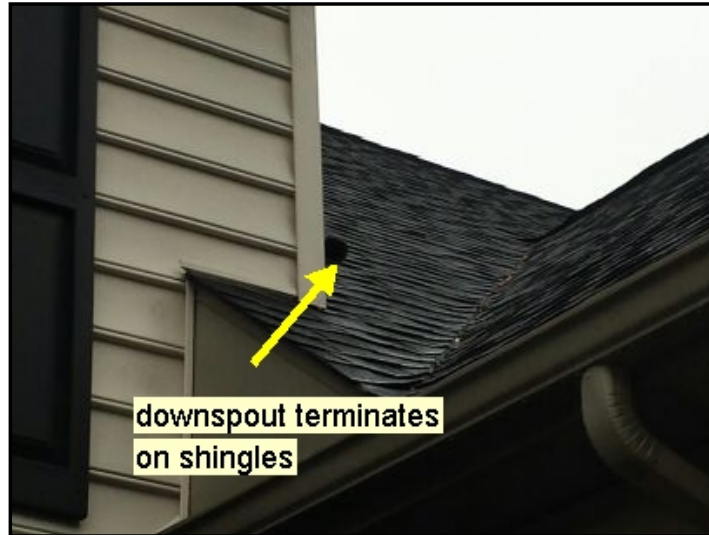
- No major system safety or function concerns noted at time of inspection.
- Downspout on Southeast drains directly on the roof shingles. This can cause premature wear and damage to the shingles. Recommend extending downspout to gutter below.

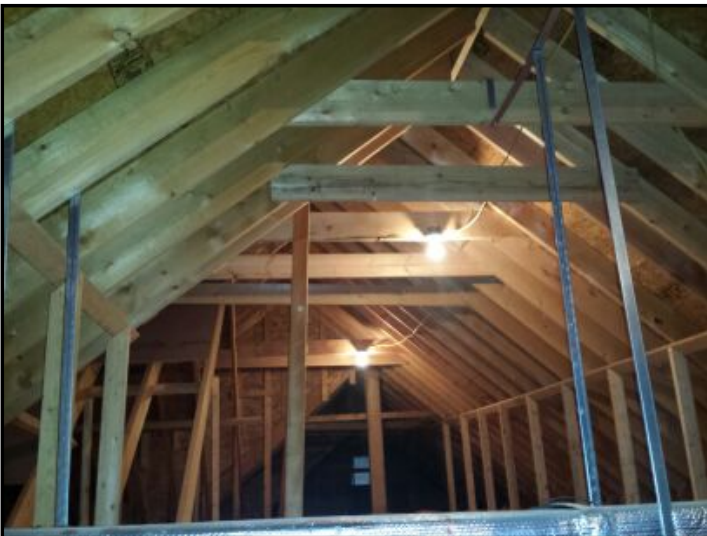
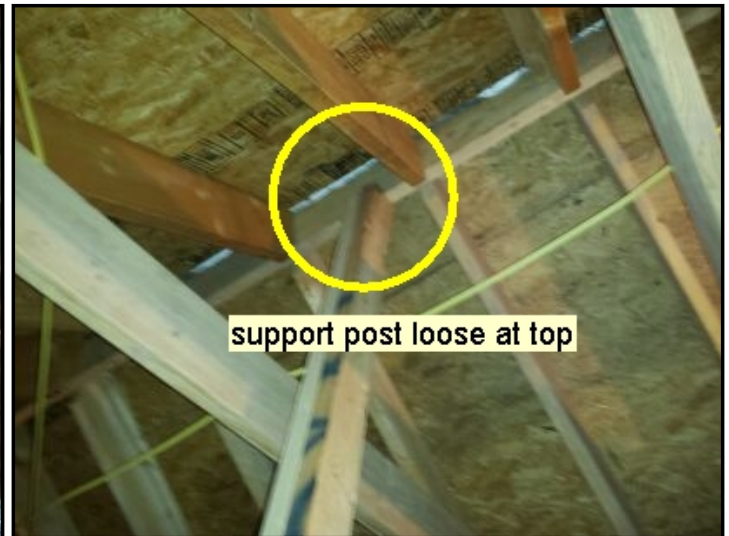
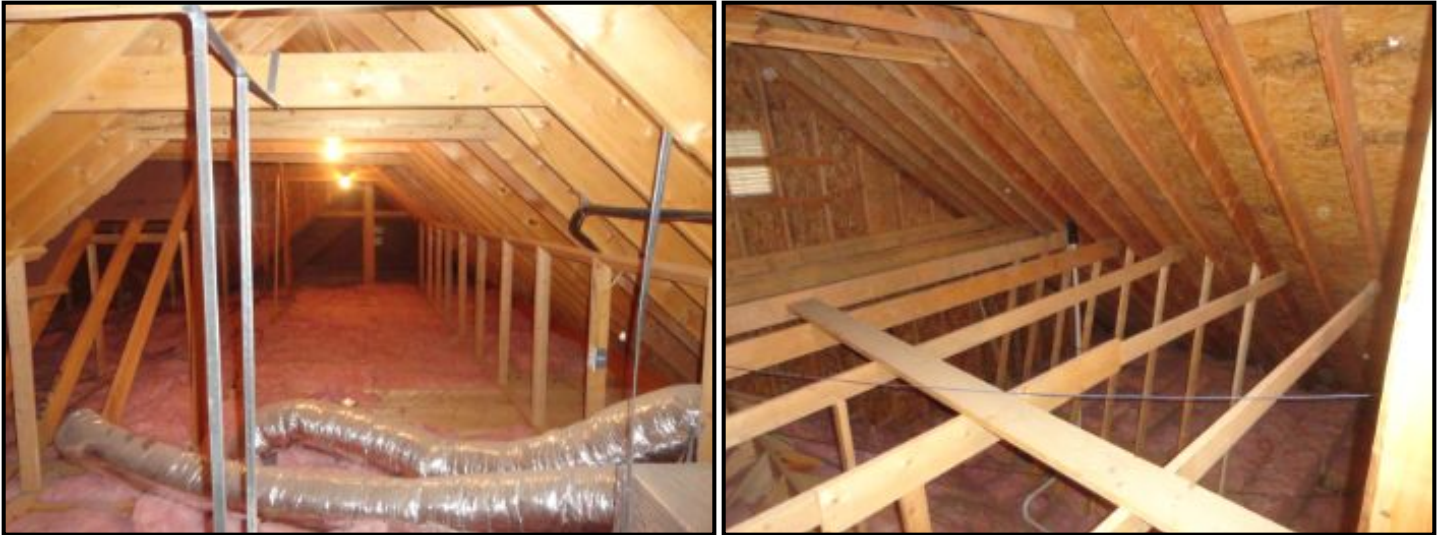
- The truss system is conventional framing, and appeared to be in good condition at the inspection.
- **A vertical roof brace on East side of attic is not attached at the top.**

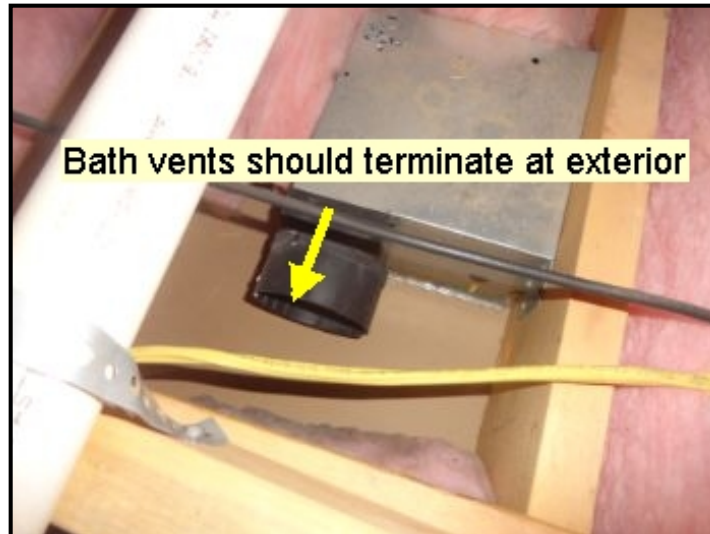
- The fan for bath at top of stairs (upper level) terminates improperly in the attic. This can create excessive moisture. Recommend directing the vent towards the exterior to allow for proper ventilation. <http://www.charleston-home-inspector.com/content/bath-vents-attic>

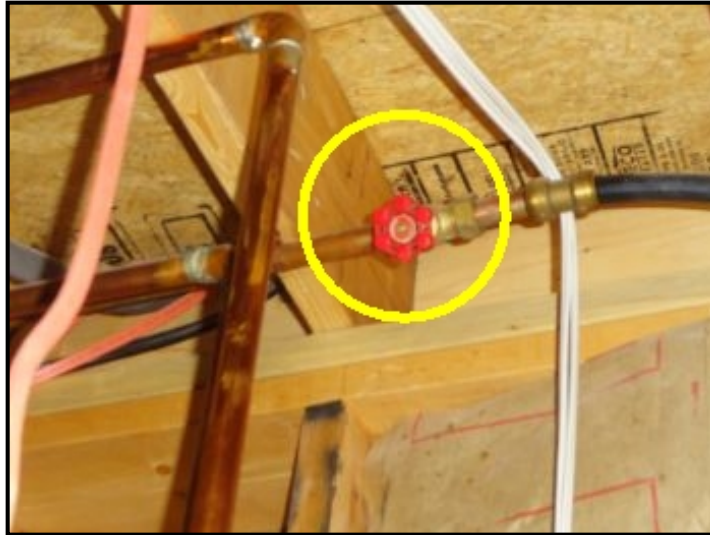
Main Water Shut off Valve

- Appears Functional.
