Inspection Connection

Property Inspection Report

123 Main Street, Anyplace, WV
Inspection prepared for: Mickey Mouse
Date of Inspection: 12/3/2014 Time: 10:00am
Age of Home: 2009 Size: 5200
Weather: recent rain

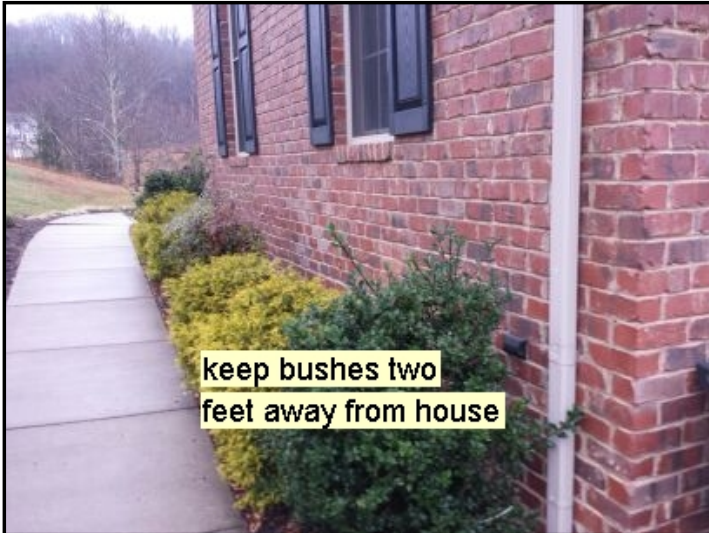
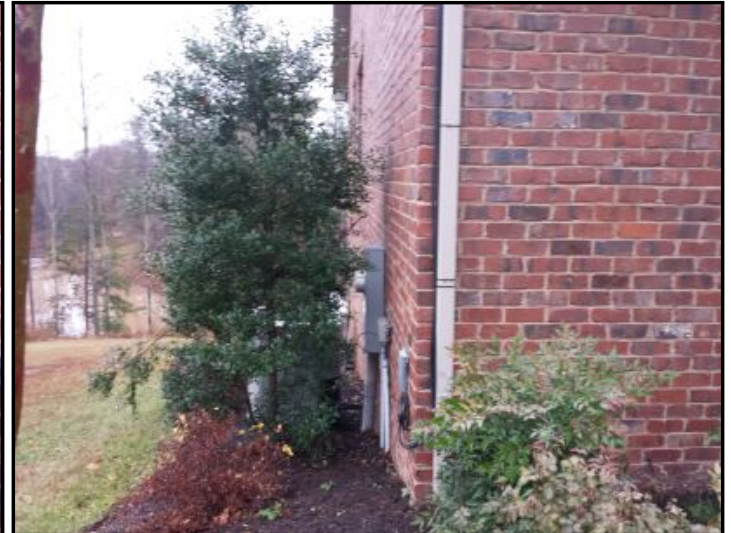
- Maintenance Tip: When landscaping, keep plants, even at full growth, at least a foot (preferably 18 inches) from house siding and windows. Keep trees away from foundation and roof. Plants in contact or proximity to home can provide pathways for wood destroying insects, as well as abrade and damage siding, screens and roofs. <http://www.charleston-home-inspector.com/content/pros-and-cons-greenery>
- Trim trees that are in contact or proximity to home, as branches can abrade roofing or siding.
- Trees that grow too close, or overhang property, should be trimmed back. This will help reduce the frequency of having to clean out the gutters, which should be done on a regular basis.

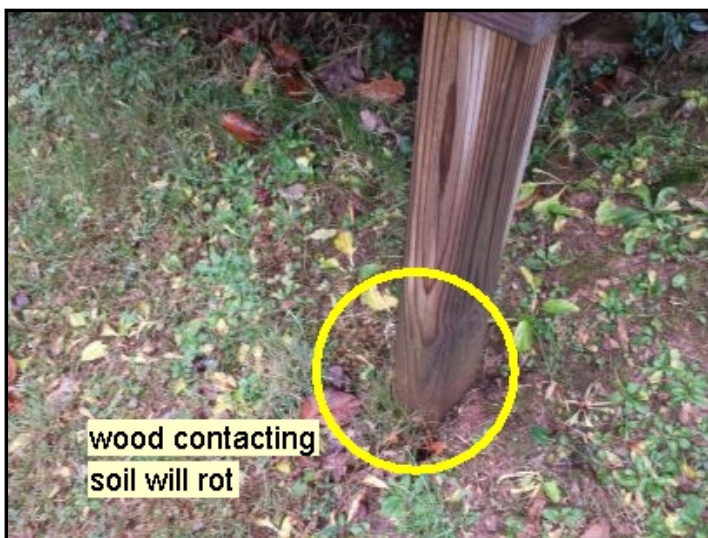
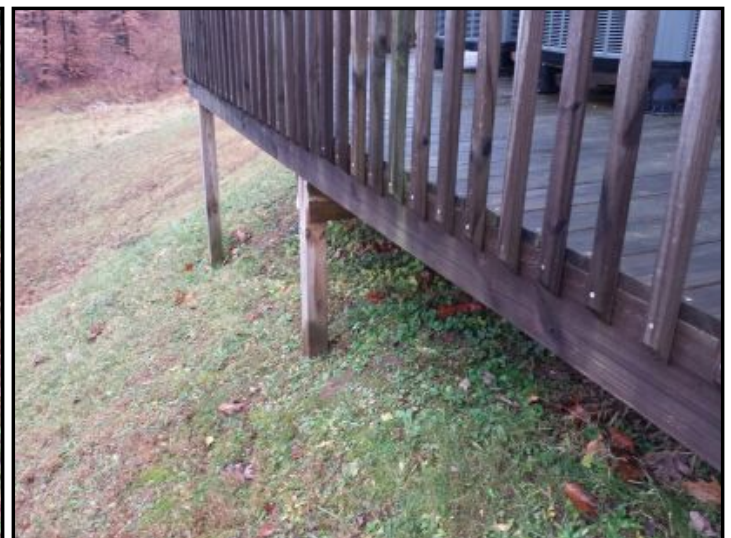
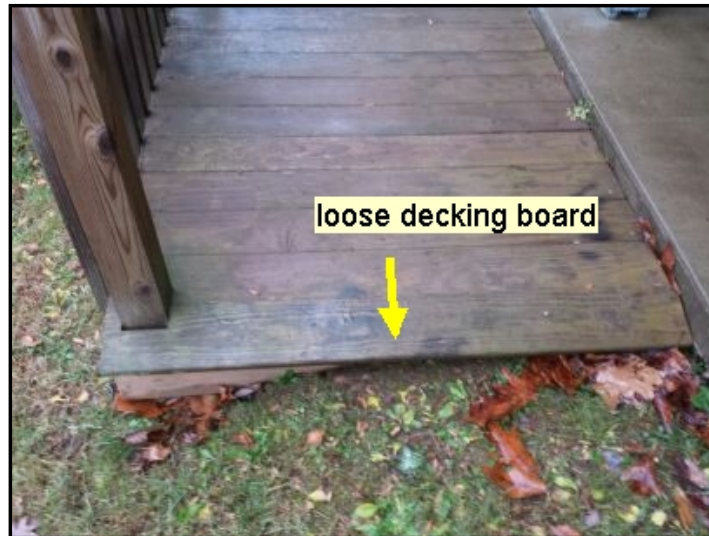
- **MAINTENANCE:** Whether treated or not, it is important to keep a wood deck surface free of all forms of fungal growth and debris that retains moisture and will cause the deck to eventually rot. Recommend cleaning and resealing the deck annually. Cleaning can be accomplished by scrubbing the deck with a sodium-hypochlorite (bleach) and Tri-Sodium-Phosphate (TSP) deck wash and then rinsing with a pressure washer. Finally, a wood deck should be recoated with a high quality deck sealant.
- **Clean and Seal Deck:** Recommend cleaning deck and treating with a waterproof sealant claiming to waterproof, block ultraviolet light, and stop mildew.
- **The deck board at the bottom walkway needs secured**
- **Wood to Soil Contact at deck supports. Deterioration may occur and insects may gain access to wood.**

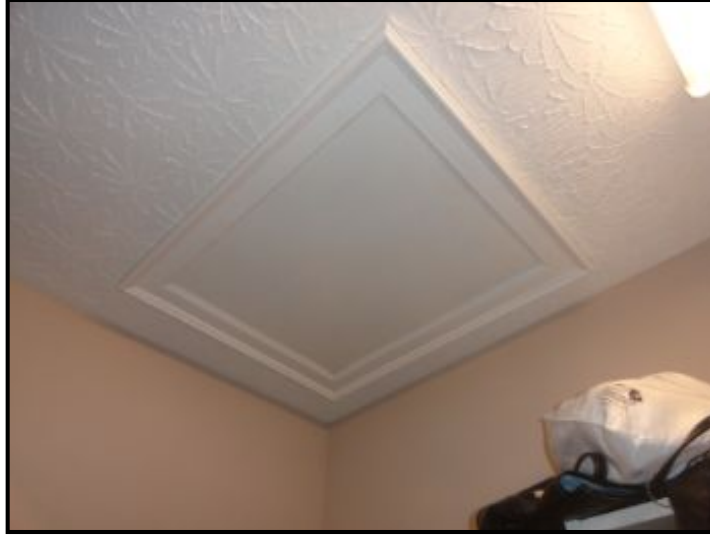
- The truss system is conventional framing, and appeared to be in good condition at the inspection.
- **A vertical roof brace on East side of attic is not attached at the top.**
